**A Study for the Improvement,
Restoration, and Protection...**

**Nyona Lake Lions Club
Lake Enhancement Committee
Fulton County, Indiana**

Earth-Source Inc

June 1990

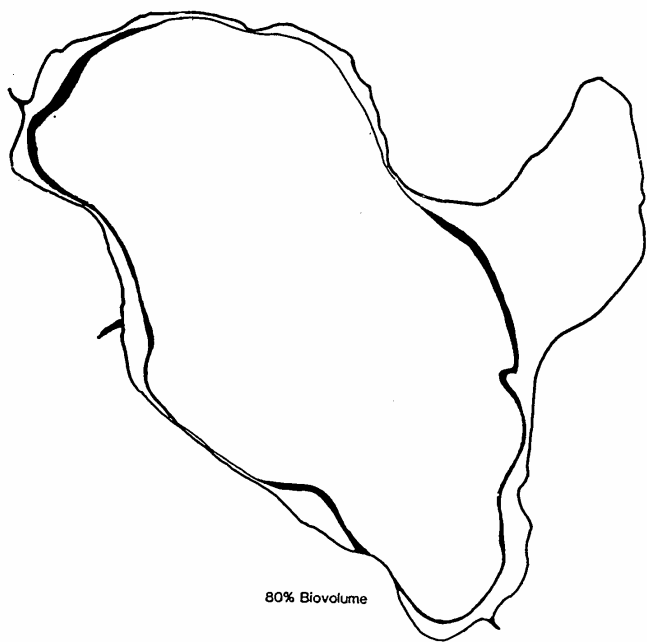
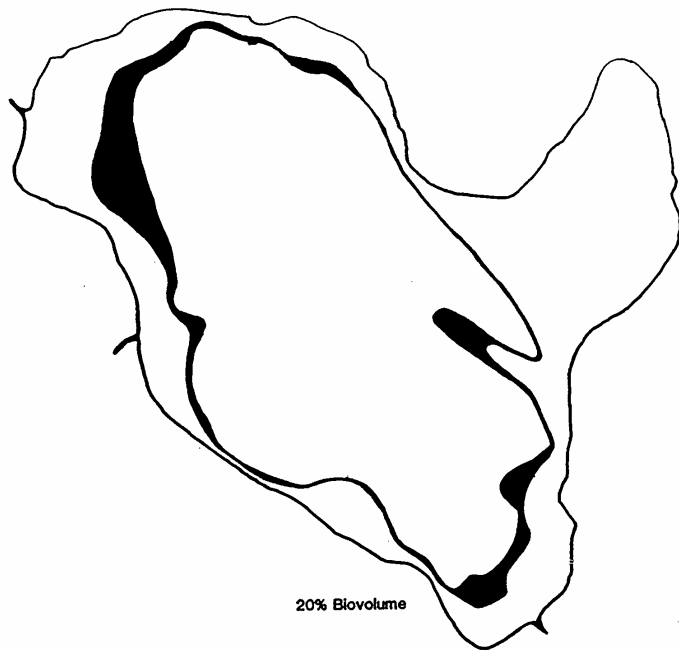
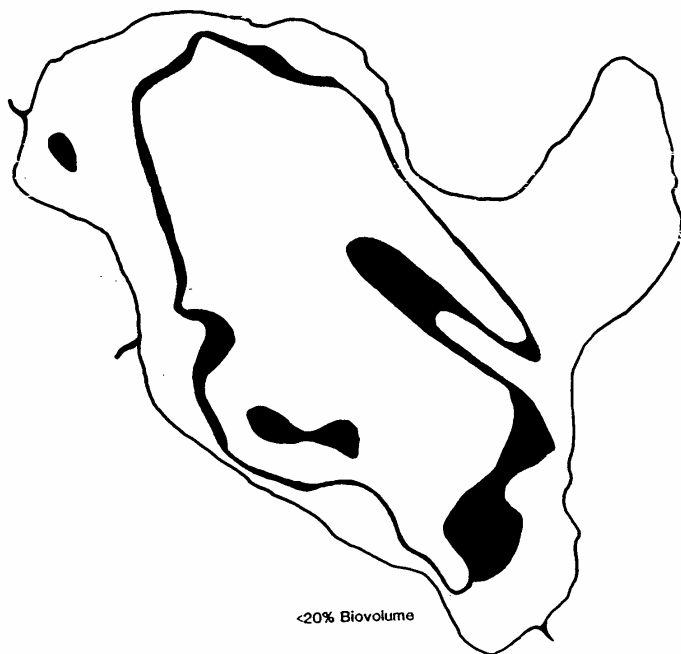
Figure 64. Plant Biovolume at South Mud Lake in
Increments of 20% Water Column Infestation.

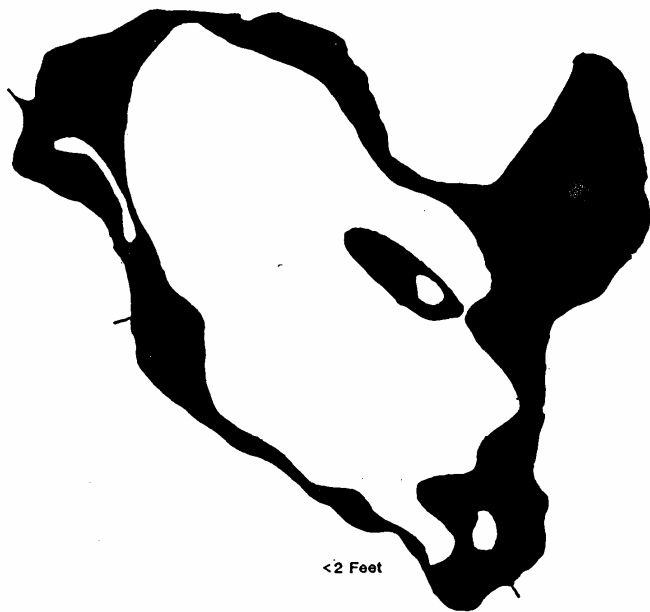
Figure 67. The Distribution of Aquatic Plant Height in South Mud Lake by 2 Foot Height Increments.

South Mud Lake was less than 2 feet tall (Figure 67). The results suggest that most weed problems along the shore are associated with short vegetation that completely fills the water column. As noted earlier, aquatic plant growth is minimal in water less than 5 feet while the deepest sections of the lake are completely weedless due to pronounced light limitation for plant growth.
